RAILWAY INVESTIGATION REPORT

R99H0007

DERAILMENT/COLLISION

VIA RAIL CANADA INC.

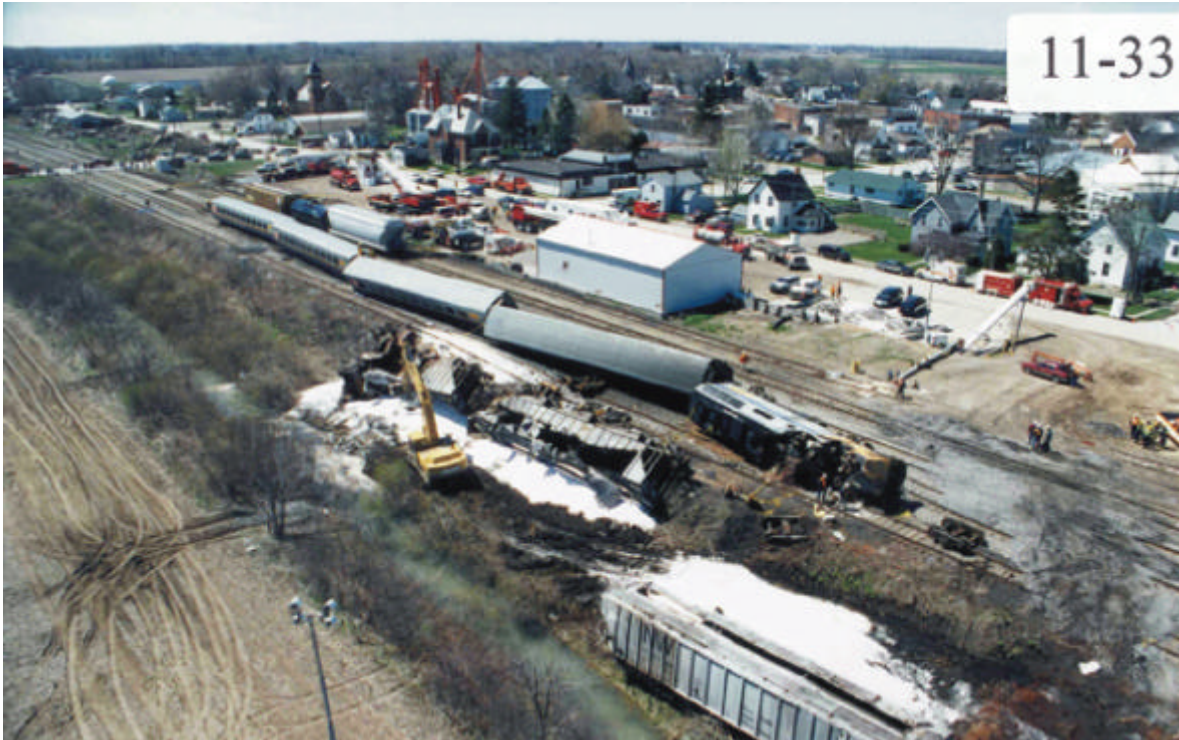
Figure 1 - Overhead photograph of accident site looking north-west

Marks on the top of the rail consistent with a wheel flange and extensive damage to the track ties and roadbed indicate that the locomotive derailed approximately 48 feet (15 m) east of the east crossover switch. The head end of the train, after derailling, moved laterally to the south, striking stationary rolling stock on track CB40. The train continued moving eastward striking additional pieces of stationary rolling stock for a distance of approximately 165 feet (50 m), coming to rest with the locomotive on its right side. The four cars of the train derailed, the first three of which were leaning to the right-hand side at decreasing angles from the first to the third.

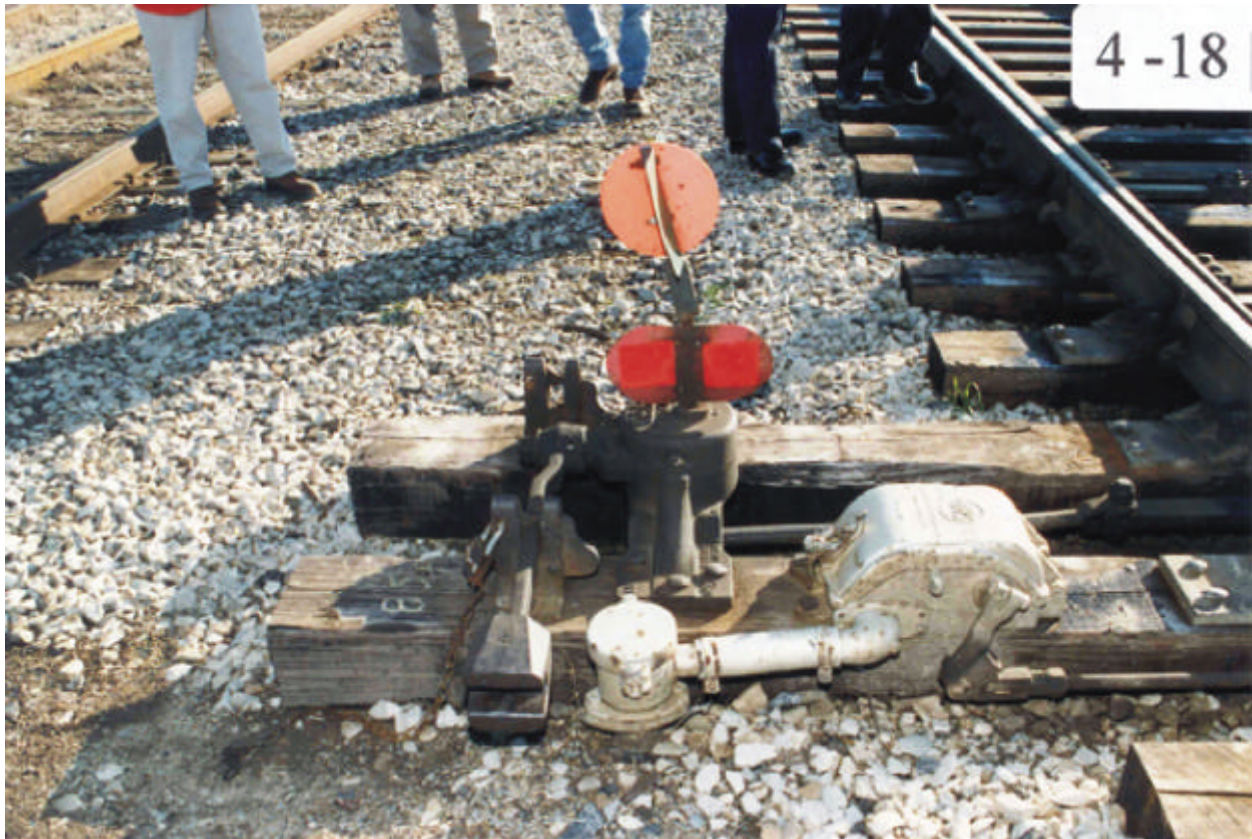
Figure 3 - West crossover switch, Mile 46.72, lined and locked in the reversed position

The west crossover switch was found lined and locked for the crossover route. The east crossover switch stand was severely damaged but the switch handle was lined and locked for the crossover route. There was no indication that the east crossover switch point rail had been forced open by any wheel flanges, and the connecting rod from the switch points to the switch stand was not bent in the manner typical of a switch being run through.⁵ This information indicates that the east crossover switch was also lined for the crossover route. Approximately 24 feet (7 m) east of the east crossover switch, the south rail of the south main track was broken. Severe scrapes along the gauge side of the rail continuing westward for approximately 14 feet

Each crossover switch was equipped with two targets displaying red for the reversed position and one target displaying green for the normal position (see Figure 3). Affixed to a square steel mast that ascended straight up out of the centre of the switch mechanism was an oval-shaped target 30.5 cm long by 15 cm high. This target had been painted red and had two rectangular pieces of high-intensity reflective material on its surface, one on each side of the centre line. Both the paint and reflective material were soiled and had experienced considerable surface degradation. The bottom of the oval target was about level with the top of the rail. An additional length of square steel rod extended from the top of the mast fastened by a sleeve and securing bolt. Affixed to this extension were two additional targets at 90 degrees to each other, one round and one square. The round target faced the same way as the oval target and was also painted red. The paint was faded and no additional reflective material had been applied. The square target, facing away from the train movement, was painted green. The round target was 20 cm in diameter and the square target was 20 cm by 20 cm. The bottom of these targets was approximately 27 cm above the top of the rail.

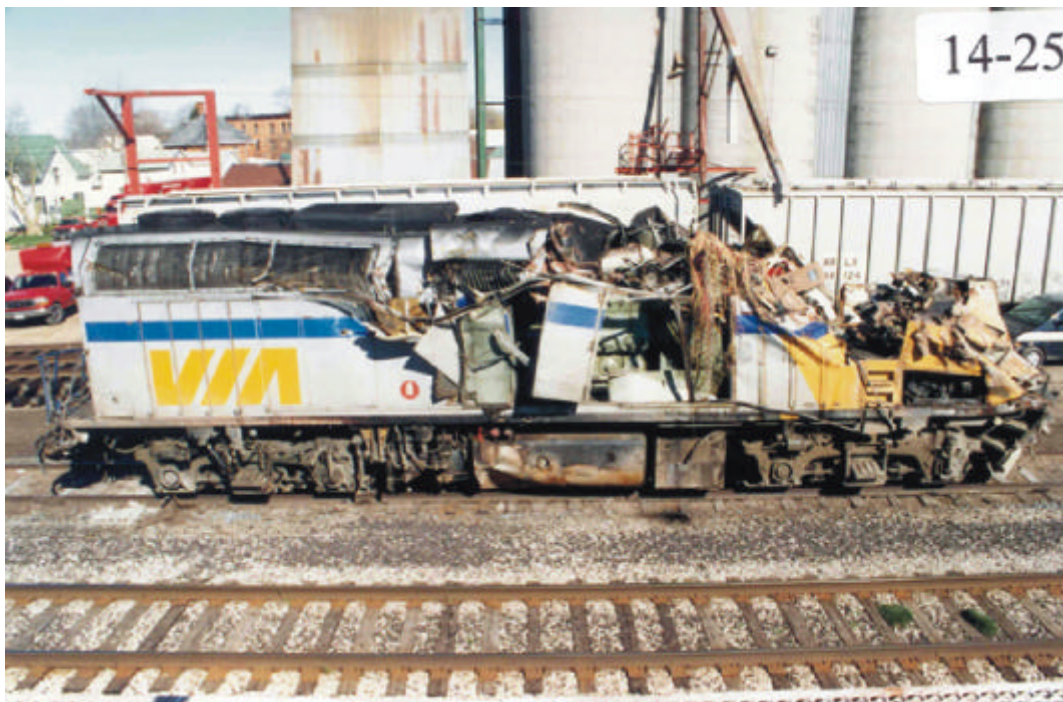
Figure 4 - Right side shown after locomotive was righted.
Damage is more extensive at the front right and along the right side of the locomotive.

The short hood and roof of the locomotive had inadequate energy-absorbing capability to protect the occupants of the cab from an impact of this severity. The rocking motion that occurred as the locomotive negotiated the crossover ultimately led to its colliding in a rightward leaning orientation with the stationary loaded covered hopper cars. Because of this orientation, the locomotive sustained a frontal impact in an area least resistant to damage—the short hood and roof.

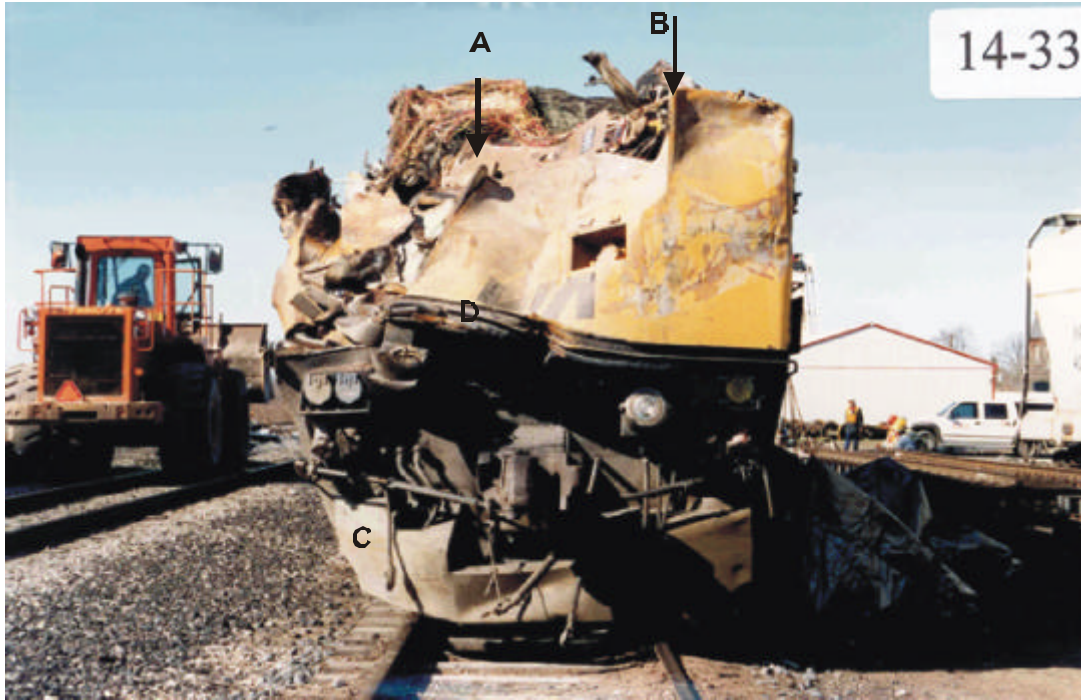
Figure 5 - View of locomotive from front after having been righted.
A - Right collision post B - Left collision post C - Pilot D - Anti-climber

- Collision Posts - The right collision post was forced aft and to the left whereas the left collision post was not significantly displaced. Even though the left collision post was not visibly deformed, the short hood near the top of the post was dented and sheared away. The right collision post was not bent along its length; however, the top of it was pushed aft. The structure which supports it at the bottom of the underframe was fractured. Close examination of the left collision post found similar damage to its underframe support structure, but which had not progressed to the same extent.

- Pilot and Vicinity - The right end of the pilot was pushed aft, while its left side was comparatively undamaged. The left ditch light was not broken. A large number of fine scratches on the surface of the right end of the pilot were consistent with having been caused by contact with the roadbed. The pilot or its surrounding area beneath the underframe did not contain deep gouges or severe structural damage as seen on the upper surfaces of the short hood that were consistent with contact with the hopper cars.

- Anti-Climber - The right end of the anti-climber was bent upwards. One gouge was observed on the underside of the anti-climber consistent with impact with the hopper cars. It is considered that much of this upwards bending likely resulted from damage to the underframe when the right collision post was forced aft.

- Short Hood - The short hood on the right was pushed back along with the right collision post. The short hood on the left was dented and sheared near the top of the left collision post. The left side of the short hood at the base of the collision post did not show any significant impact damage. The right side of the short hood contained numerous deep gouges in the metal where it contacted the loaded covered hopper cars.

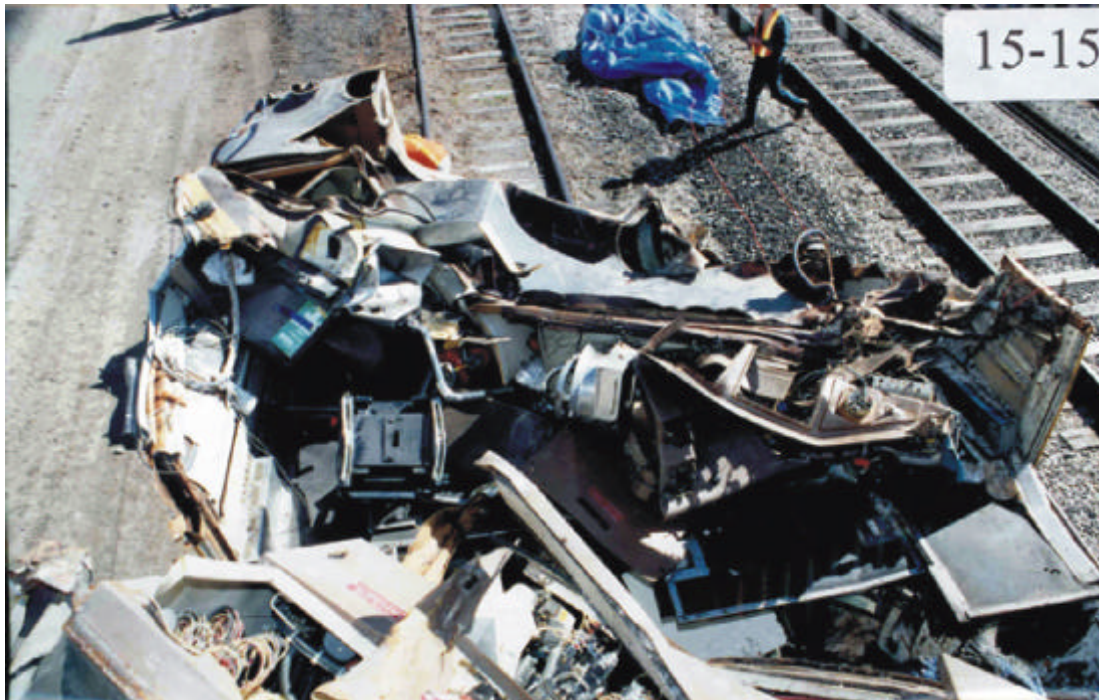
Figure 6 - Interior of cabin looking forward from top of locomotive

- Control Cabin - The roof of the cabin was found separately, and was considered to have been torn away by the collision. The electrical cabinet, located behind the operators, was pushed towards the rear, more on the right than on the left. On the right side, the control console and short hood were pushed back beyond the

operator's seat and downwards almost level with the cabin floor. On the left side, the operator's seat pedestal was still securely fastened to the floor, was visibly deformed towards the rear, and was not covered by the short hood or console. No buckling was observed in the cabin floor.
